PUBLIC ROADS

NOVEMBER 1937

CHANNEL CHANGES ON FOREST HIGHWAYS

Reported by H. D. FARMER, Senior Highway Engineer, and A. B. LEWELLEN, Chief Engineering Inspector-Superintendent, District 1, Bureau of Public Roads

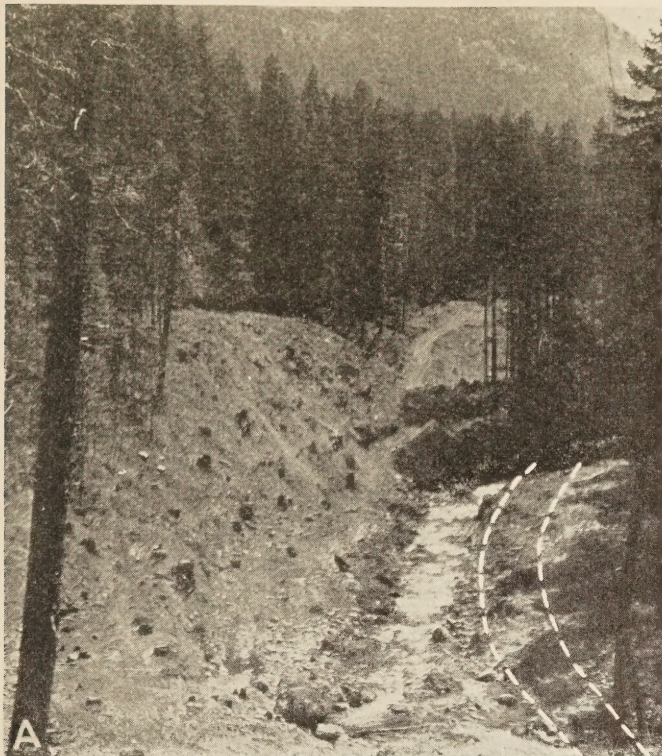
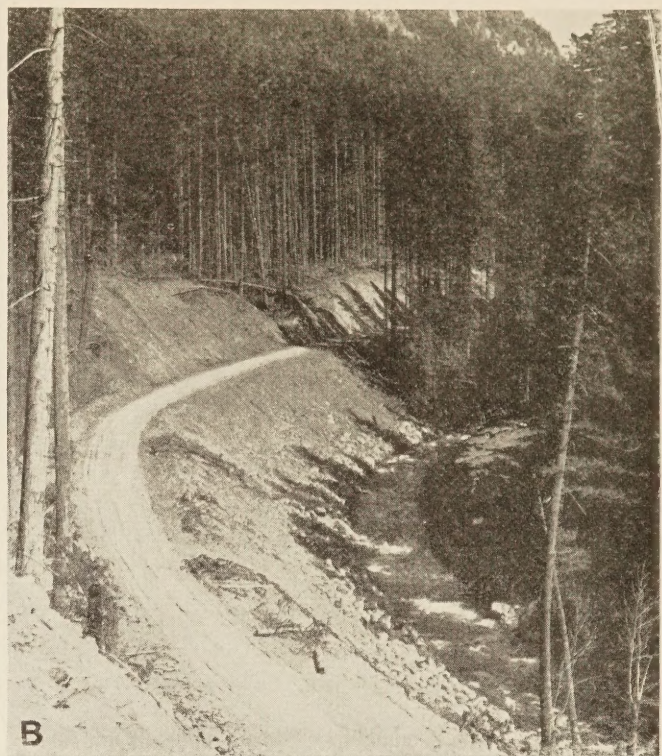
FIGURE 1.—ORIGINAL TERRAIN AND COMPLETED ROAD AND CHANNEL CHANGE. A, THE DOTTED LINES MARK THE CHANNEL CHANGE LOCATION. B, THE HIGHWAY FILL SLOPE IS RIPRAPPED AT THE BOTTOM WHERE IT SERVES AS ONE BANK OF THE STREAM.

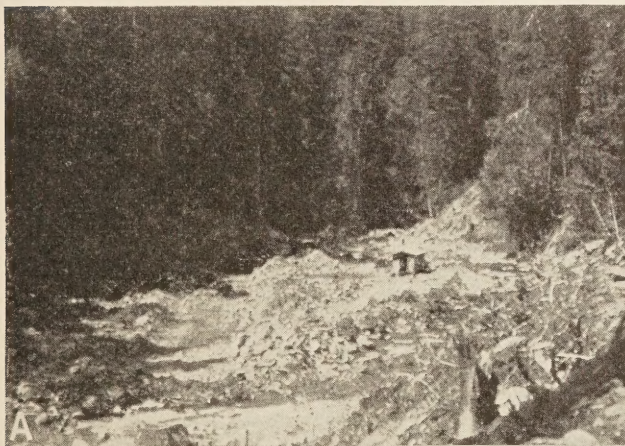
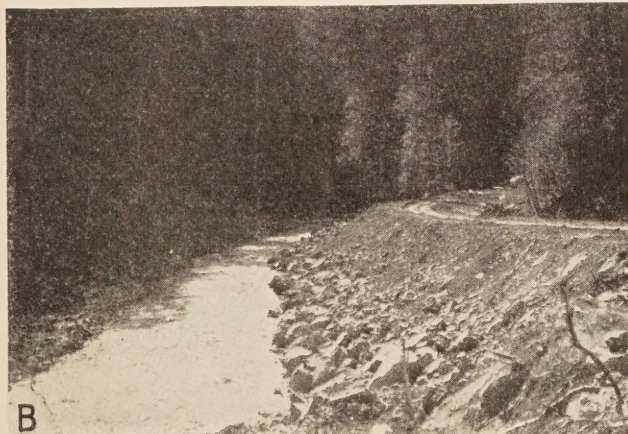
FIGURE 2.—A, ORIGINAL TERRAIN; AND B, COMPLETED CHANNEL CHANGE.

Figure 2, A shows the original terrain looking downstream from station 1728, and figure 2, B shows the completed channel change and road. The road has a curve of 6°30' and its grade increases from 3.5 to 5.2 percent. The grade of the road exceeds the grade of the stream bed so that the road gradually rises above the stream.

The channel is 38 feet wide at the bottom. The new channel is 500 feet long and required 2,100 cubic yards of excavation. Rock for slope protection was obtained

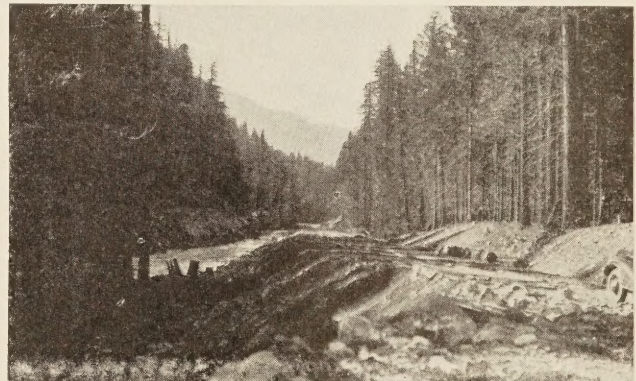
FIGURE 3.—A COMPLETED CHANNEL CHANGE THAT DIVERTS THE STREAM FROM ITS ORIGINAL CHANNEL ENTIRELY.

from adjacent roadway excavation. The stream was diverted entirely from its original channel.

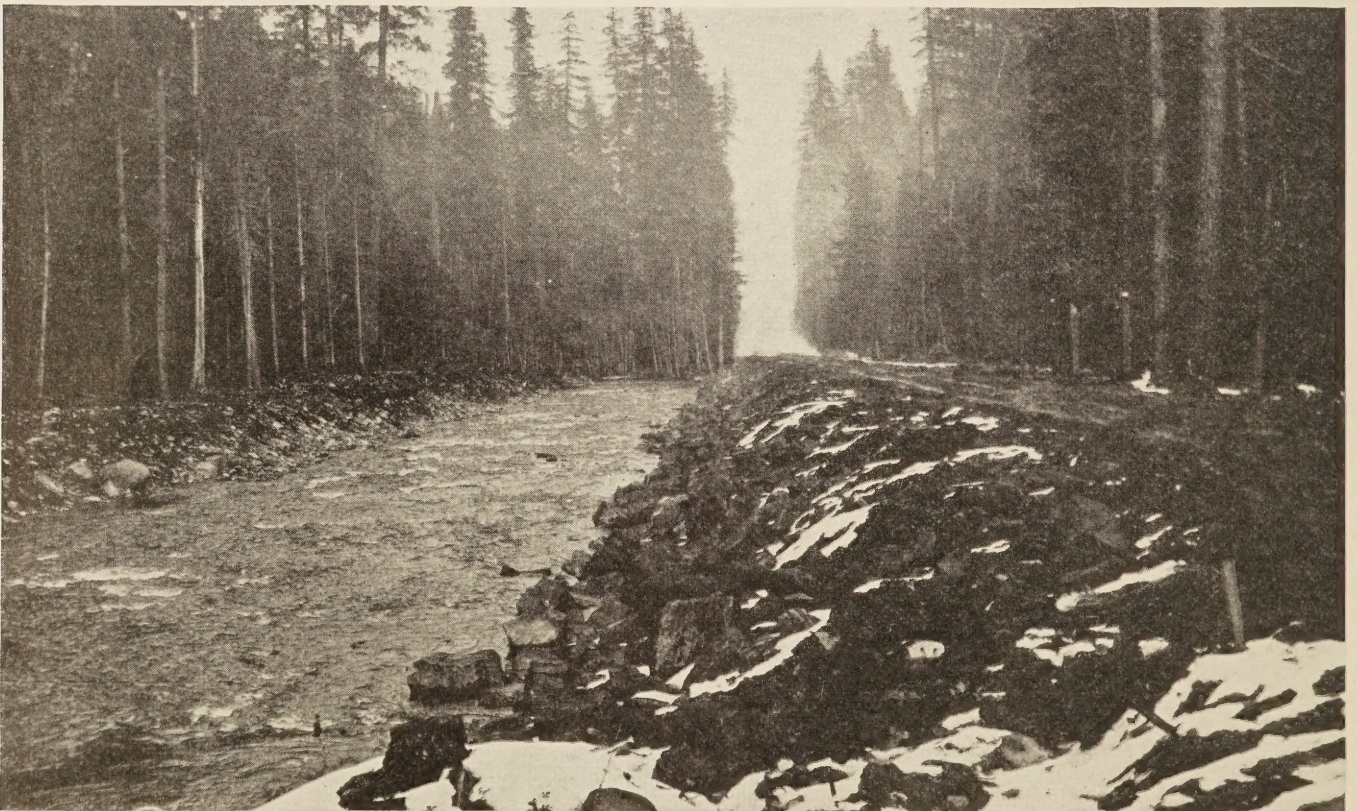
The large boulders remaining in the stream were later used for slope protection.

Lower, the left bank of the channel is cleared of vegetation to permit erosion.

FIGURE 6.—PROGRESS DURING CONSTRUCTION OF A CHANNEL CHANGE.

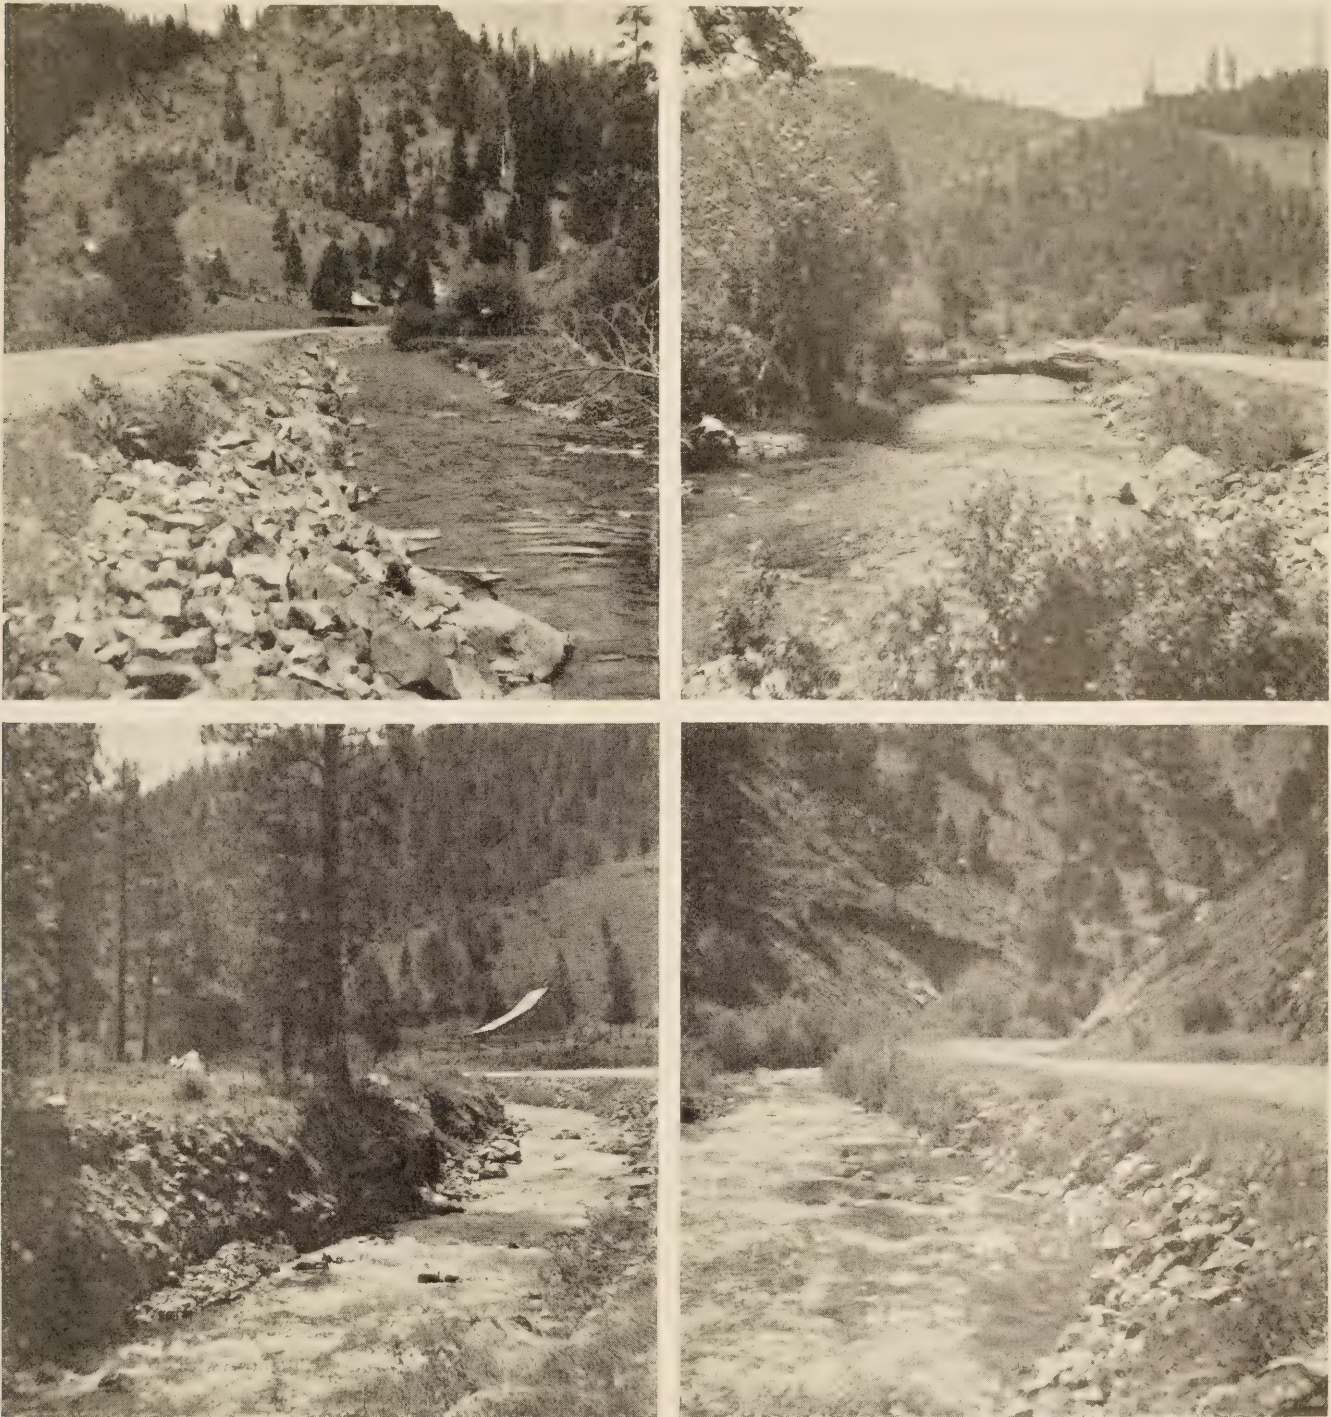
FIGURE 7.—TYPICAL CHANNEL CHANGES USED TO BENEFIT ROAD LOCATIONS.

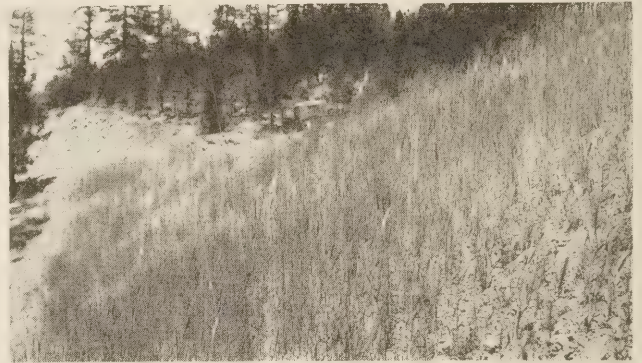
FIGURE 1.—A HIGHWAY FILL 8 MONTHS AFTER CRESTED WHEAT HAD BEEN PLANTED.

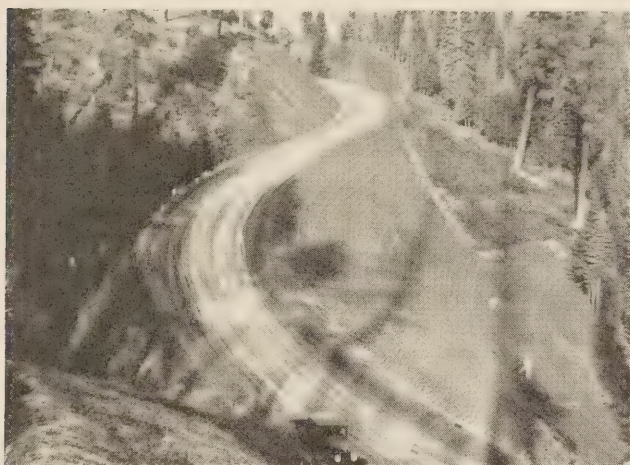
FIGURE 2.—WILLOW CUTTINGS PLANTED ON A HIGHWAY FILL TO PREVENT EROSION.

In view of the favorable conditions existing on this road, the erosion control considered necessary involved stabilizing the fill slopes to an adequate depth below the surface. This was done by planting willow cuttings 3 feet long to a depth of 30 inches in the fill slopes. The cuttings were planted in rows following contour lines, spaced at vertical intervals of about 3 feet between rows. The spacing of the cuttings in rows varied from 1½ feet on the highest fills to 3 feet on small fills.

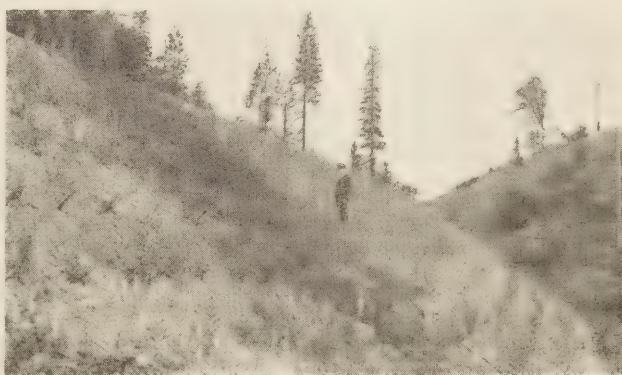
FIGURE 4.—APPEARANCE OF A FILL 9 MONTHS AFTER WILLOW CUTTINGS HAD BEEN PLANTED.

Excellent results were obtained on most of the fills planted with willow cuttings. Figure 4 shows a fill that had no failures. Although some of the plants shown in this figure may die, the majority should flourish and afford ample protection for revegetation by indigenous shrubs and small plants.

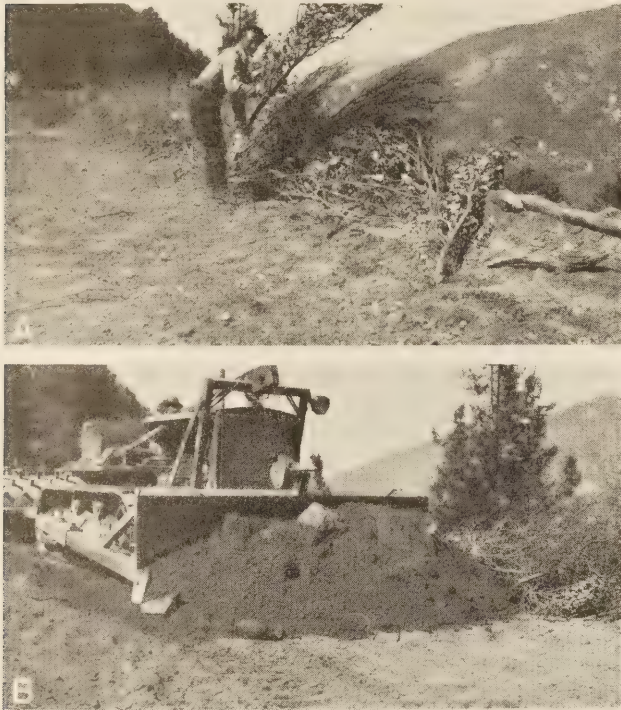
FIGURE 5.—A; PLACING A LAYER OF BRUSH. B; A BULLDOZER COVERING A BRUSH LAYER WITH EARTH. THE BULLDOZER IS PULLING A SHEEPSFOOT ROLLER USED TO COMPACT THE FILL.

The placing and covering of brush layers are shown in figure 5.

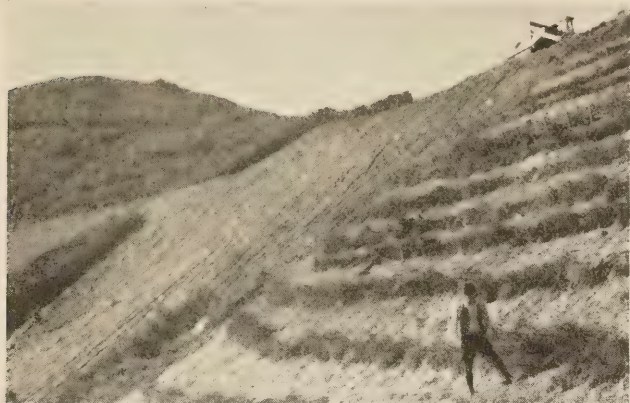
FIGURE 6.—APPEARANCES OF PROTECTED AND UNPROTECTED FILL SLOPES AFTER A HEAVY RAIN.

The protected fills were subjected to a severe test in February 1936 during construction. Approximately 10 inches of rain fell, at times approaching the rate of 1 inch per hour. After this storm, damage to protected and unprotected slopes was noted. (See figs. 6, 7, and 8.)

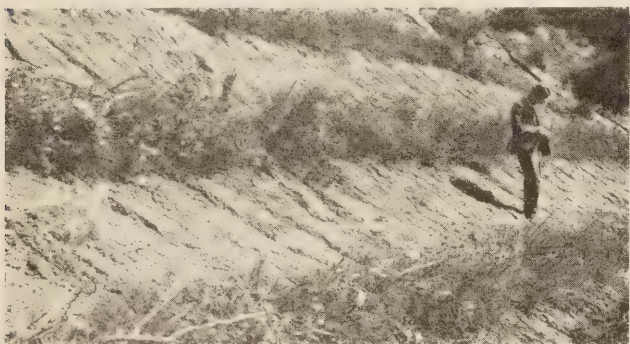
FIGURE 7.—FILL SLOPES PROTECTED ACCORDING TO METHOD A. PICTURE SHOWS A SECTION ABOUT 70 FEET BELOW GRADE.

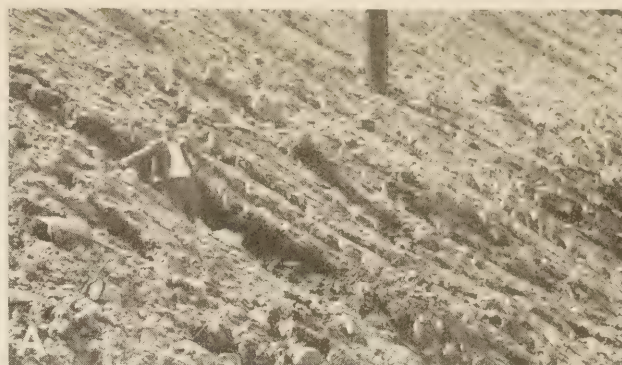
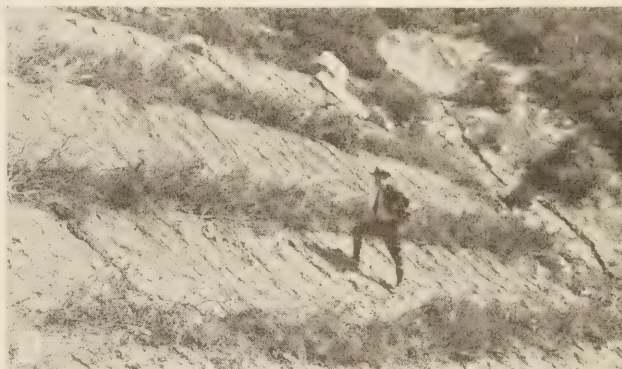
FIGURE 8.—SECTIONS OF FILL SLOPES ABOUT 70 FEET BELOW GRADE. A; EROSION ON AN UNPROTECTED FILL. B; A FILL PROTECTED ACCORDING TO METHOD A.

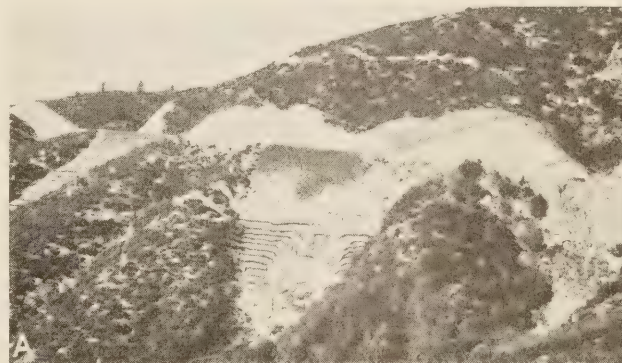
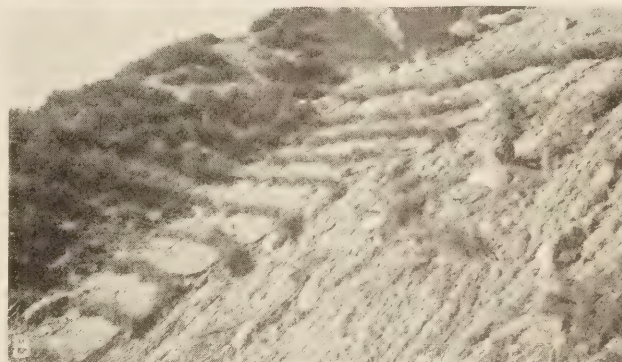
FIGURE 9.—DAMAGED FILLS THAT HAD BEEN PROTECTED BY BRUSH WATTLES (METHOD C).

been some slips of wattled fills, but little erosion or loss of material has occurred on brush-treated fills. Figure 9 shows damage to fills protected according to method C. No protection work was performed on the upper sections of the fills shown in figure 9 because of the rocky material present.

The failure of wattles on some fills was probably caused chiefly by slippage of the surface material. Apparently the wattles were not as well anchored to the fill as were the rows of brush laid according to methods A and B.

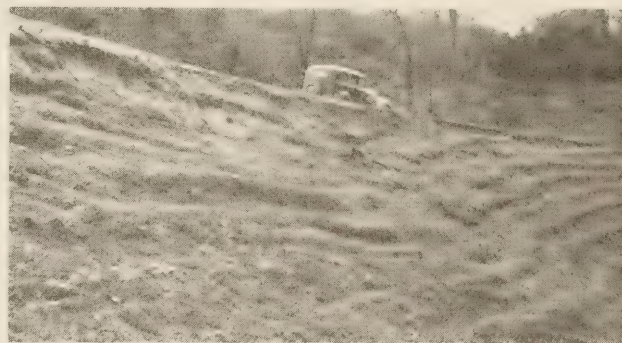
FIGURE 13.—PARTIAL FAILURE ON A FILL PROTECTED BY HAY WATTLES.

Some slipping occurred on one of the large fills having a northern exposure. This failure, which amounted to 25 percent of the area of the fill, represented less than 4 percent of the total area protected by hay wattles. Partial failure of a fill protected by hay wattles is illustrated in figure 13.

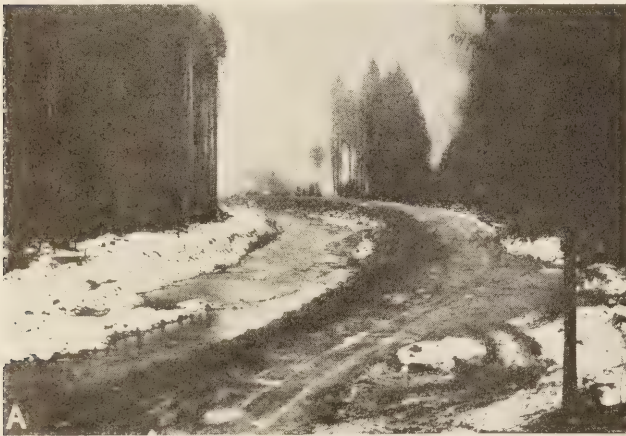
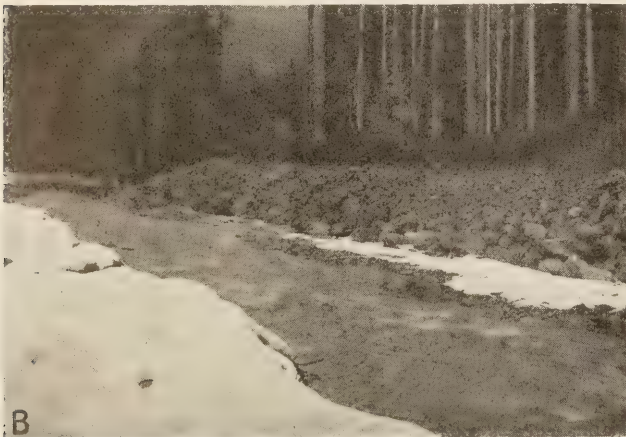
FIGURE 8.—TWO CHANNEL CHANGES: A, THIS CHANNEL CHANGE STRAIGHTENS A MEANDERING STREAM. THE RIPRAPPED SLOPE BEARS THE FULL FORCE OF THE CURRENT AROUND THE CURVE. B, THE LARGEST ROCKS ARE PLACED AT THE BOTTOM OF THE RIPRAPPED SLOPE.
